# CASE HISTORY TOYOTA MR2 TURBO

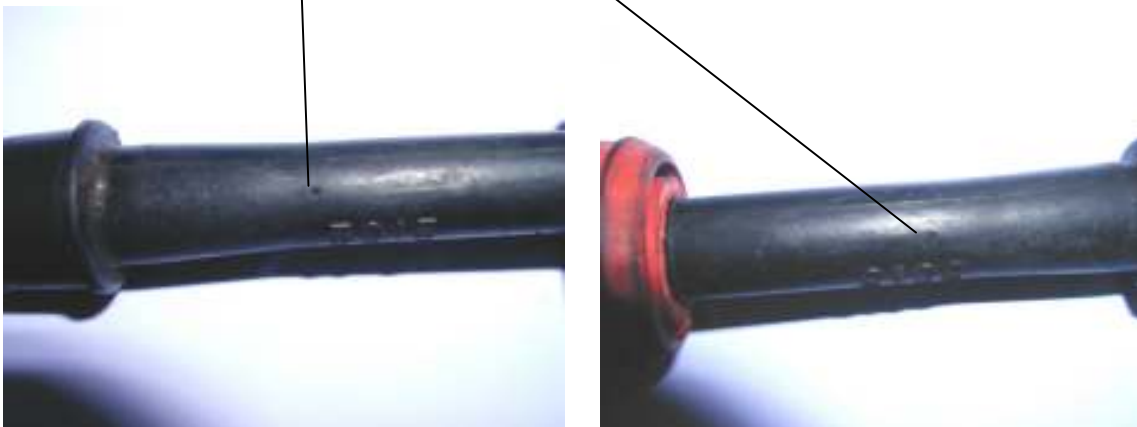
WE WERE ASKED TO DIAGNOSE A PROBLEM WITH A TOYOTA MR2 TURBO. THE HISTORY WITH THE VEHICLE WAS THAT IT HAD DEVELOPED A MISFIRE UNDER LOAD AFTER BEING FILLED WITH DIESEL. INVESTIGATION UNDER LOAD ON OUR ROLLING ROAD USING OUR HIGH SPEED FLUKE LAB SCOPE REVEALED THE PROBLEM .THE HT LEADS WERE LEAKING THROUGH THE SIDE OF THE INSULATORS CAUSING A LOSS OF IGNITION ENERGY TO THE PLUGS. THE PROBLEM HAD NO RELATIONSHIP TO THE DIESEL FILL AND WAS PURELY COINCIDENCE.

SMALL HOLE IN  
INSULATOR WHERE THE  
SPARK HAS BEEN  
LEAKING THROUGH
