CASE HISTORY TOYOTA LEXUS

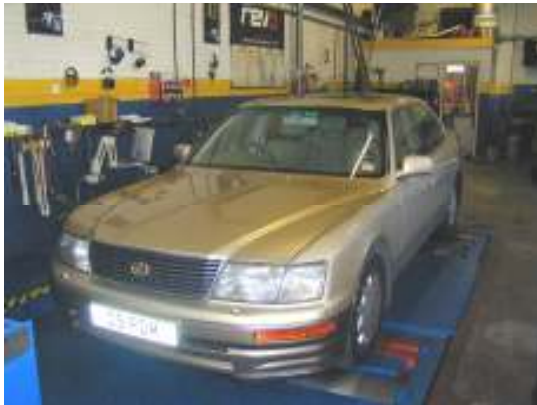
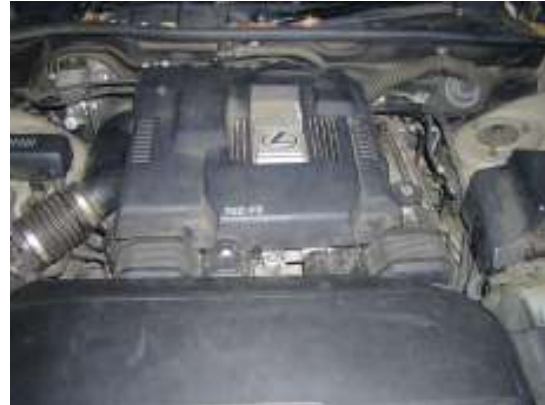
Re-reading the fault memory showed the fault for rpm \ phase sensor. Further investigation and testing revealed that the wiring for the camshaft sensor had chafed through on the cam cover, rewiring the sensor cured the fault although long term a new sensor was required.

Upon advising the customer we were told that the car had recently had a cam belt change and it was obvious that the cam sensor wiring had been routed incorrectly.
