2003 NISSAN MICRA 1.5 DCI

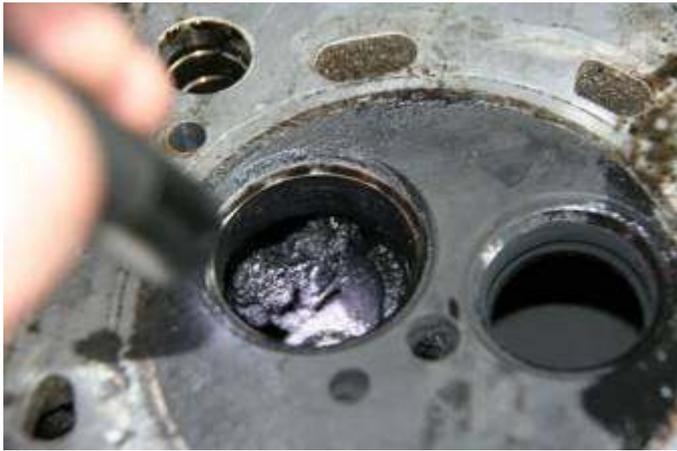
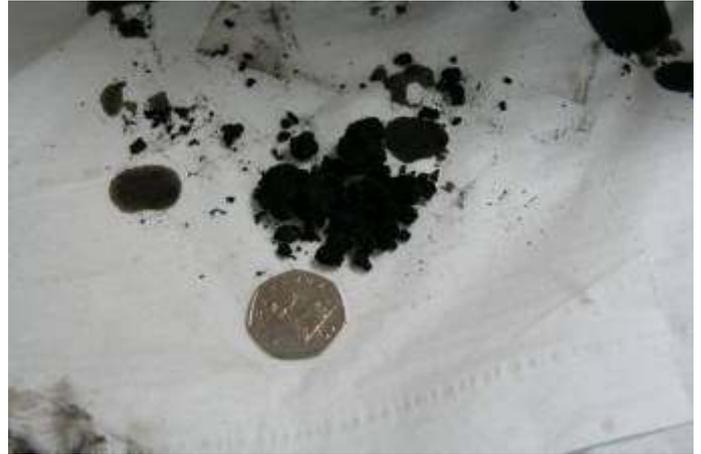
We were asked to investigate a fault on a Nissan Micra 1.5 DCI with the engine management light coming on, reading the fault memory revealed a P0301 code, which interpreted as miss fire on number one cylinder. The fault only occurred on or above 2,800 rpm at this point the engine would drop a cylinder and could visibly be seen to miss fire with some visible smoke best described as grey in colour. Our first course of action was to remove and have the Delphi injectors tested, two were found to be poor including the offending number one cylinder. The injectors were reconditioned installed and recoded but the same fault was present. Our next course of action was to swap injector position re code and re asses but again the fault was still the same on the same cylinder. Having eliminated injectors we next considered a mechanical issue causing this fault. Compression testing and cylinder leakage revealed nothing both were even across all cylinders. At this stage we decided posting on the Frank Massey Network to see if anybody could shed any light on the fault, several suggestions were made one being a previous case of a blocked inlet port, having no other option the customer was advised that the next course of action was to remove the cylinder head and investigate. Customer approval given we removed the head and it was stripped and the number one inlet port was almost completely blocked with carbon. At low RPM there was enough air entering the cylinder for the injected fuel to burn but as engine RPM increased there was not enough available air for the injected diesel to burn hence the miss fire and neat diesel exiting the exhaust giving rise to excess smoke.

Looking at the inlet layout number one cylinder is furthest from the incoming air and EGR and therefore the coolest point which might account for the build up of carbon at this point.

Carbon removed, head refaced valves re cut the head was refitted and smooth running was restored the fault was cured. Analysing our diagnostic procedure after the repair we considered if we could have located this fault in a better way but with out the prior knowledge of this condition we would still use the same approach.

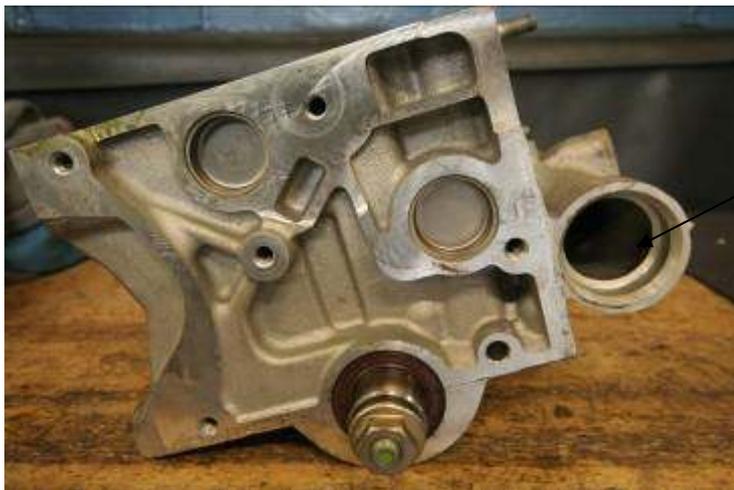
Inlet manifold layout, air mixed with EGR entering at number four cylinder and feeding all cylinders with a blanking core plug at number one cylinder where the carbon build up occurred

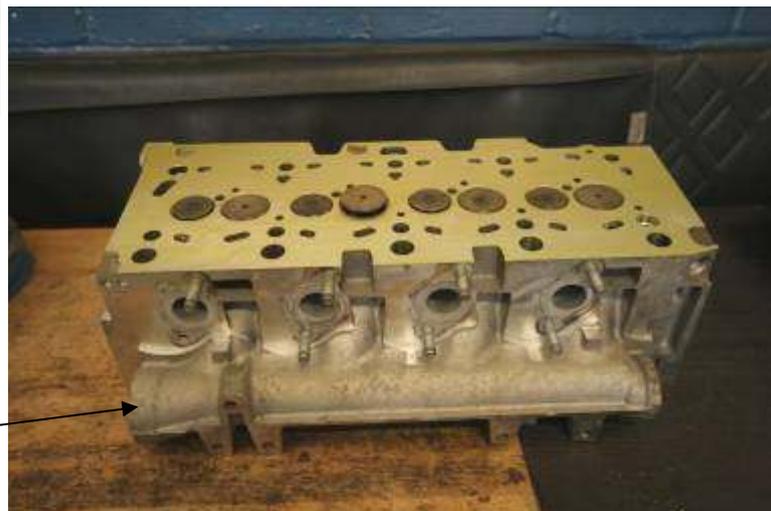
As above air entry at number four cylinder, number one is at the far end of the head the inlet manifold is blanked off with a core plug this is were the carbon build up occurred.
