# CASE HISTORY TOYOTA MR2 TURBO

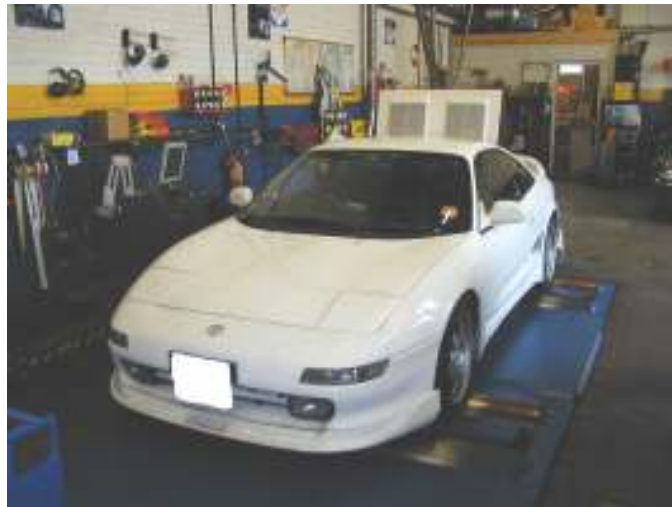
WE WERE ASKED TO DIAGNOSE A PROBLEM WITH A TOYOTA MR2 TURBO. THE HISTORY WITH THE VEHICLE WAS THAT IT HAD DEVELOPED A MISFIRE UNDER LOAD AFTER BEING FILLED WITH DIESEL. INVESTIGATION UNDER LOAD ON OUR ROLLING ROAD USING OUR HIGH SPEED FLUKE LAB SCOPE REVEALED THE PROBLEM .THE HT LEADS WERE LEAKING THROUGH THE SIDE OF THE INSULATORS CAUSING A LOSS OF IGNITION ENERGY TO THE PLUGS. THE PROBLEM HAD NO RELATIONSHIP TO THE DIESEL FILL AND WAS PURELY COINCIDENCE.
